Association pour le Développement Durable (ADD)

ADD/CF/MEHR&TESR Sandwatch Programme at France Boyer de la Giroday SSS (FBG)

Brief on the visit to Blue Bay public beach

1. Date: Friday 15 March 2019

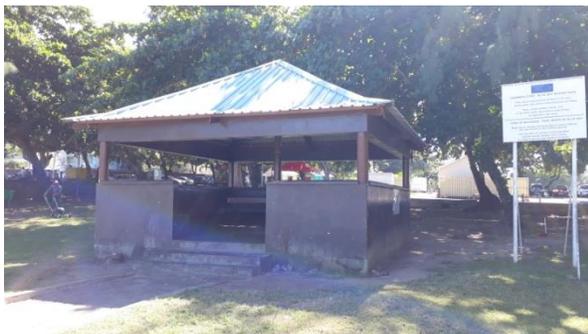
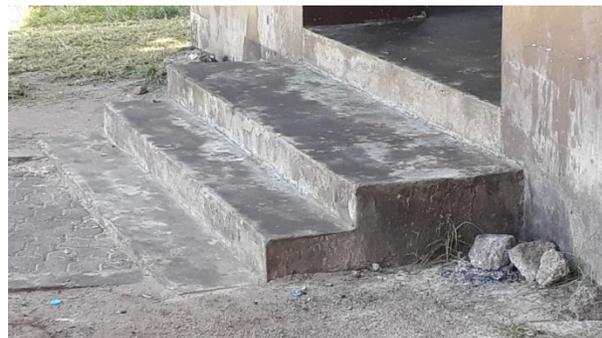
4.1. Reference Object A

This is a kiosk located on the left of the public beach when facing the sea. The reference point is the corner of the step to the right

Length of fixed point to the end of grass on the beach =19.70m
Beach width from fixed point (the extreme end of the wall) to HWM=25.90m

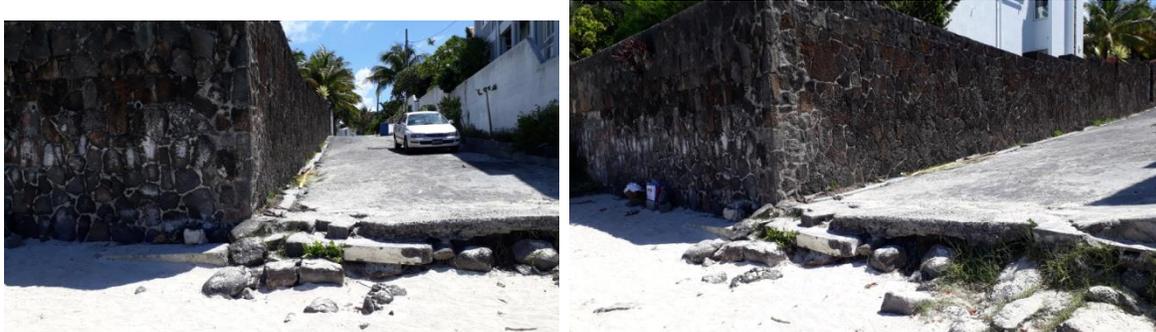
4.2 Reference Object B

The fixed object is a vertical wall situated at the entrance of a public road located about 300 m from object A.

Beach width from fixed point (the extreme end of the wall) to HWM = 4.40m

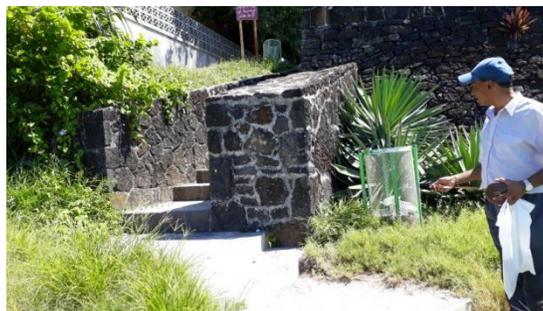
4.3 Reference Object C

The third fixed object is a vertical wall situated almost to the end of the bay at the entrance of a pathway.

Length of fixed point to the end of vegetation on the beach = 26.90m
Beach width from fixed point (the extreme end of the wall) to HWM = 32.20 m

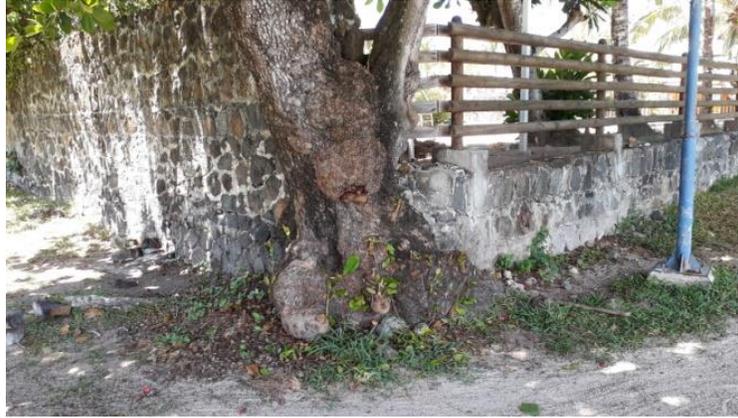
4.4 Reference Object D

A fourth reference point was taken on the public beach at the foot of a badamier tree. Erosion is quite marked nearby. It is expected that this would worsen after successive extreme weather and ocean events. The length of the vertical scarp to the foot of the tree was measured to quantify temporal changes in the future.

Length of fixed point to vertical scarp = 7.10m

Beach width from fixed point (the extreme end of the wall) to HWM = 10.80m

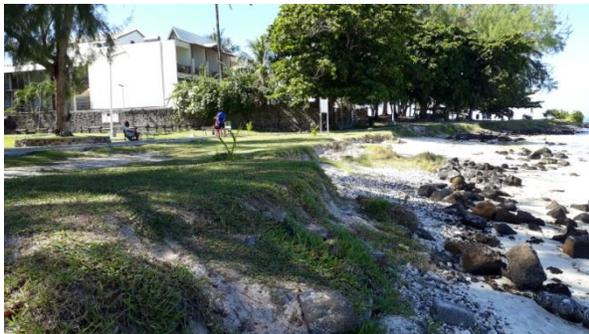
House to be used as reference in future study

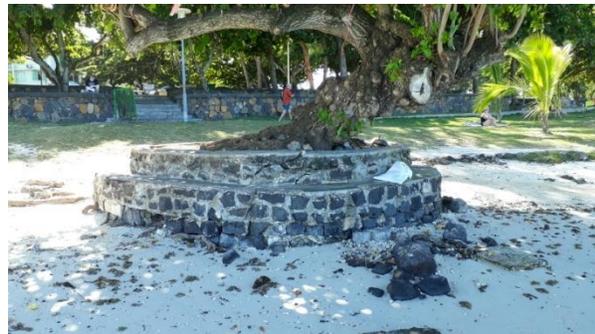
Round wall is likely to be soon impacted

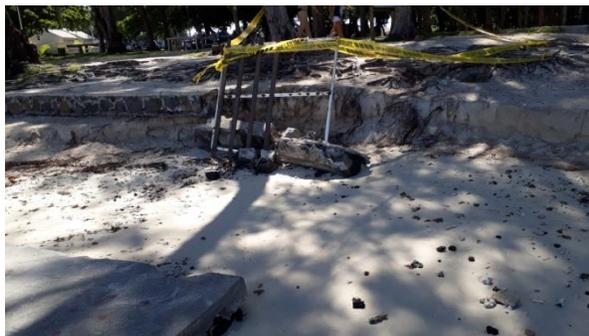
Occurred 2 wks ago and the risk site demarcated

by heavy seas. Part of the vertical wall could still be seen. He has noted that erosion is accelerating particularly in recent years. The latest event occurred about 2 weeks ago. A ‘raz de marée’ washed away tons of sand, creating vertical scarps of almost 2 m at certain places. The authorities were informed and risk areas with warning signs have been demarcated.

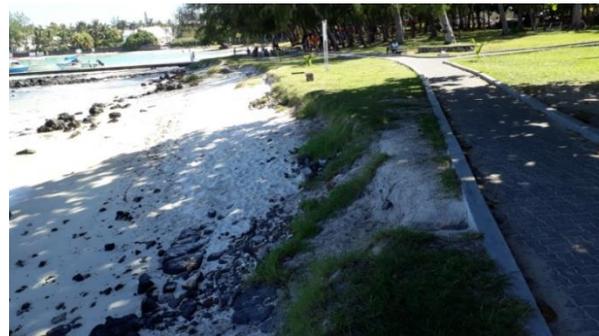
Pathway threatened by erosion

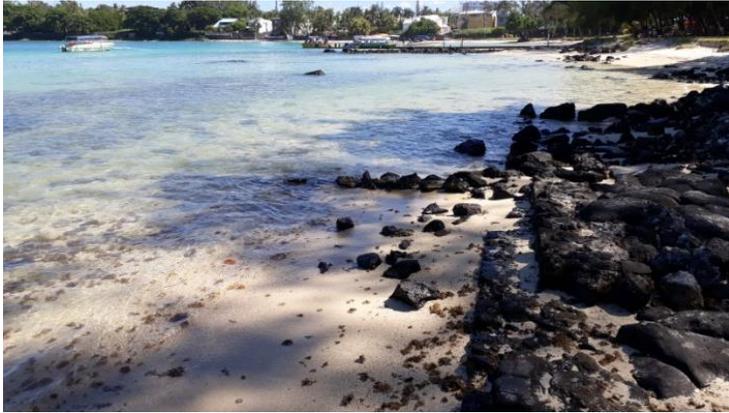
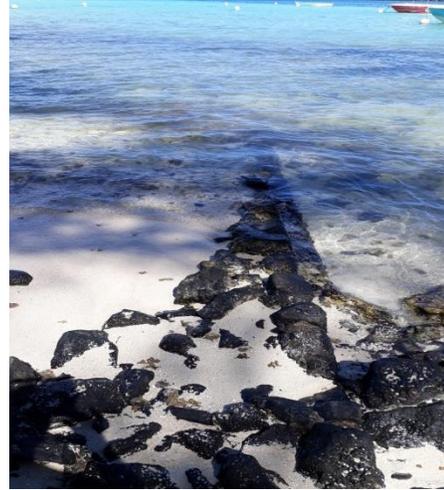
Mr. Ravee Balchand (5259 5292) has been working on the beach for almost 30 years since his childhood. He would be prepared to provide photos of the beach taken long ago. He recollected that about 20 years ago, there was a public swimming pool by the sea demarcated by vertical wall. It was gradually destroyed

Remnants of the public swimming pool
