Sandwatch Programme at La Gaulette SSS

Brief on the First Field exercise at La Preneuse Beach

Date: Friday 16 March 2018 at 10h00

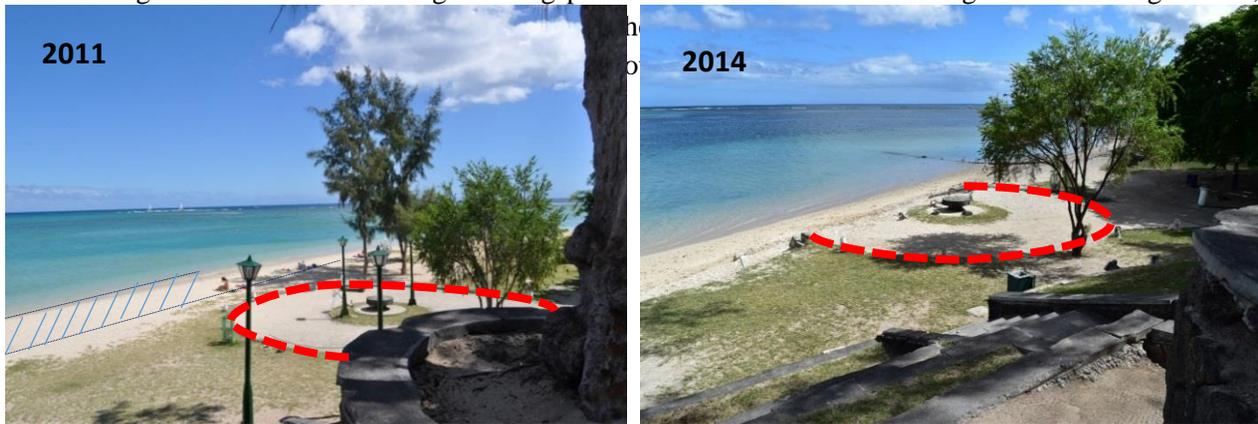
Figure 1. Shoreline change from 2011 to 2014 at La Preneuse

Four rows of sandbags have been placed along nearly 200 m of the beach about 3 years ago to protect it from further erosion. Climate change was mentioned by a teacher as one reason causing accelerated erosion in recent years. Mr. Ragoonaden availed of this opportunity to explain the effect of sea level rise on coastal erosion.

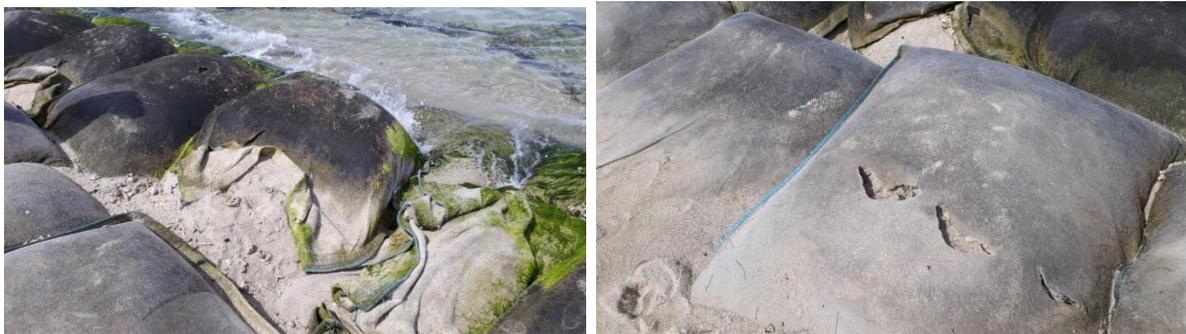
The students were asked to observe the state of the sandbags. Many were ripped open with most of sand lost. This could be due to natural forces – effect of strong waves – and trampling by human activities. The first row was now almost covered with sand. In the medium term, this line of defense could disappear and the beach would be again exposed to wave action giving rise to further erosion. Alternative measures ought to be found and students were requested to ponder on them for discussion at the end of the project.

Figure 2. Damage to sandbags due to wave actions and human trampling

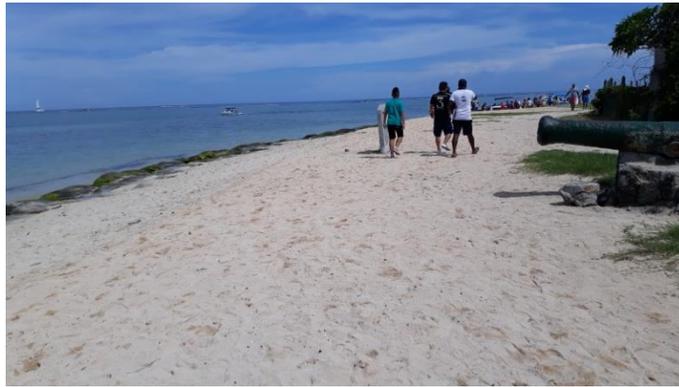
Students were requested to note the state of the beach and human activities. The beach is covered almost entirely with light yellowish white sand. It was quite clean with sunbathers and people jogging. A few debris and litter could be found scattered on the beach.

Figure 3. Yellowish white sandy beach

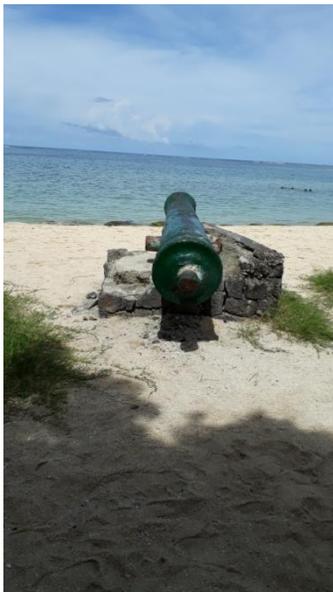
Main prominent features could be identified including a canon ball and a canal discharging rain water into the sea.

Figure 4. Canon Ball

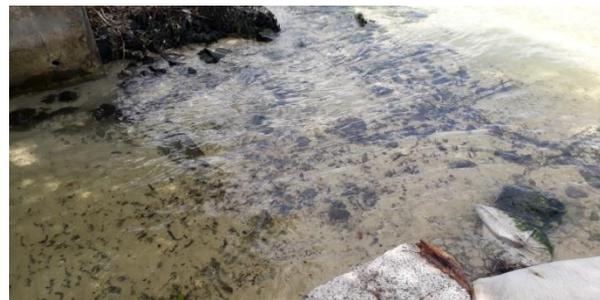
Figure 5. Canal discharging water into the sea

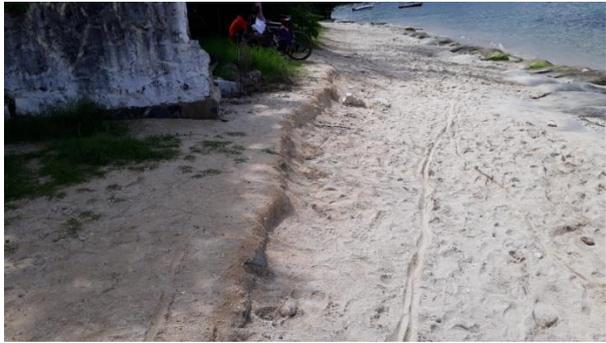
Mr. Ragoonaden explained that four reference points/objects would be identified and transect lines would be drawn from them to the shoreline for in depth studies. These are along the river canal, a white wall, the canon and region where accretion is taking place.

Figure 6. Wall and vertical sand scarp

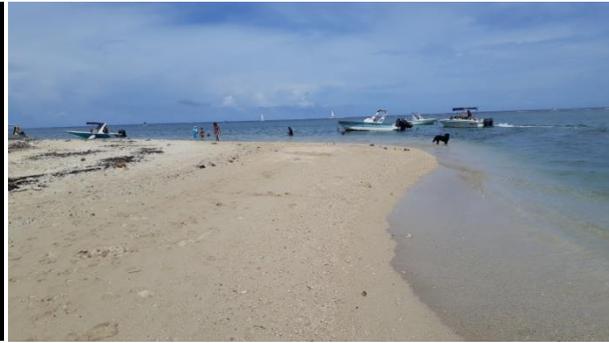
Figure 7. Accretion part of the beach

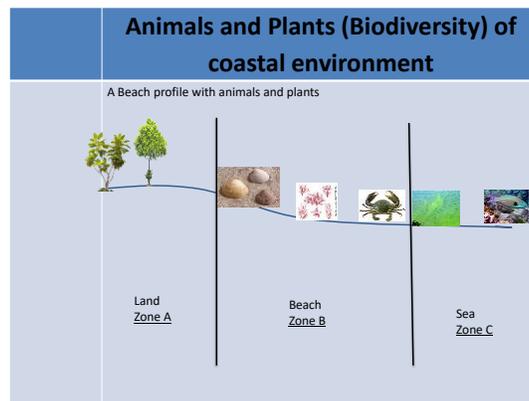
The transect lines would be divided into 3 zones for the study: high ground (terrestrial) landward of the beach, beach and sea (low and high tide limit)

Figure 8. The three zones for in depth studies
